INSULATION AND WATERPROOFING TO IMPROVE ENERGY EFFICIENCY IN BUILDINGS

### Rehabilitation with spray foam of an industrial roof in San Agustín de Guadalix (Madrid)

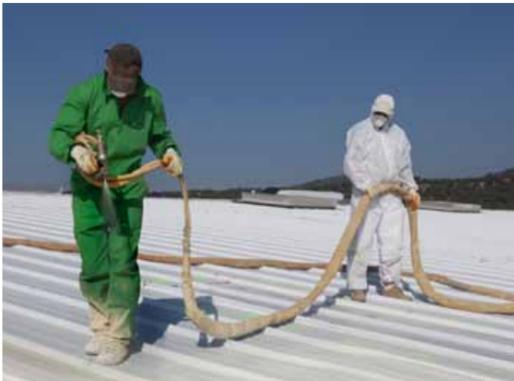
Application of spray foam on roofing

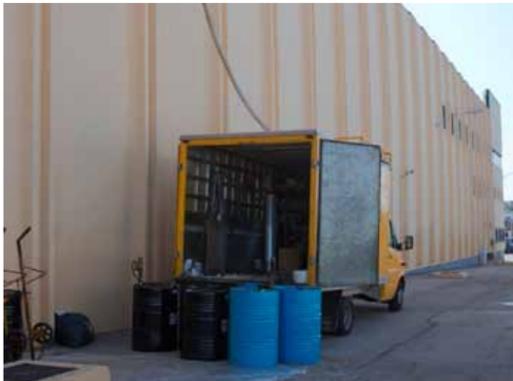
Spray foam insulation system

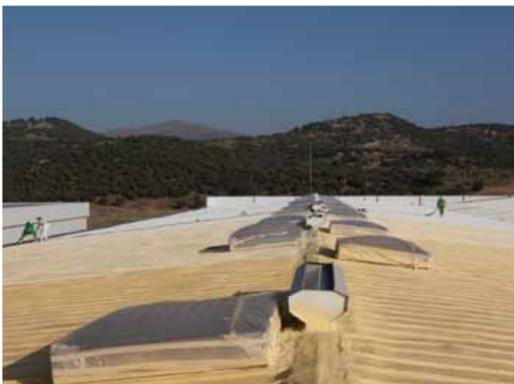
Picture of roofing elements after spraying foam

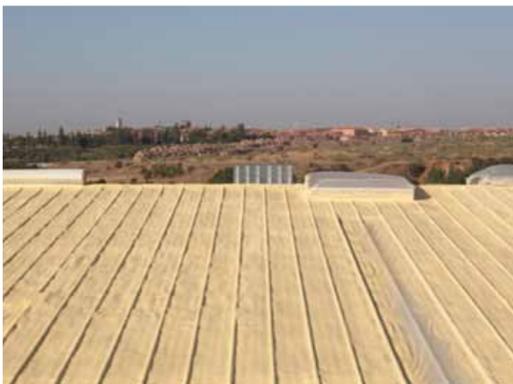
Sloping roof with spray foam

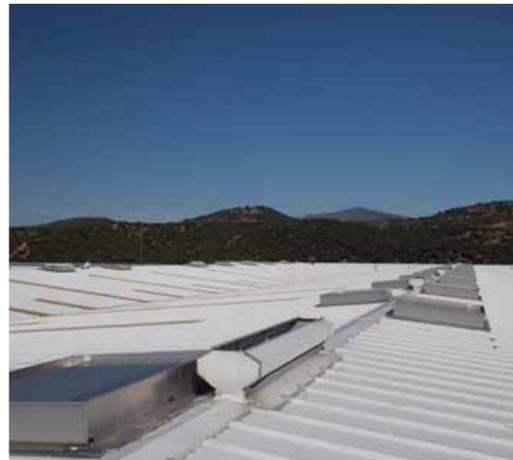
The combination of material wear of the roof and the existence of evident installation faults caused the anchorings joining the different elements (panels, skylights, chimneys, gutters and vents) to fail to provide proper watertightness. Moreover, these same anchorings had rusted and subsequently expanded, thus accelerating degradation of the roof.

Roofing elements before rehabilitation

**c) Action before spraying:** The roof was totally repaired first. Although the problem of filtrations was widespread all over the roof, different parts were treated differently. Thus, by way of example, EPDM elastomeric sheeting was used to seal areas that were difficult to reach. The top of skylights was also replaced.

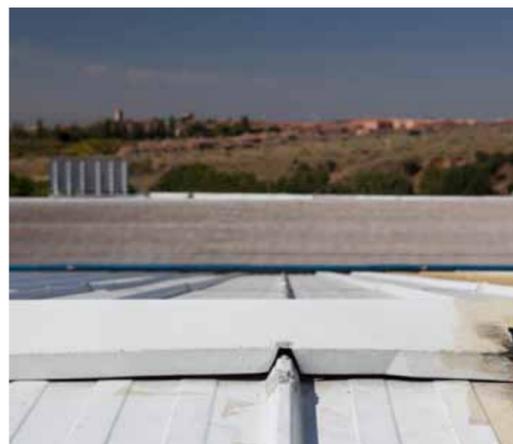
As a result of this deterioration process, the joints, which were the main focal point of the problem, gave way and the roof sheeting therefore moved during storms or in heavy rain compounded by wind, thus causing a suction effect and the subsequent filtration of water inside, even though the roof was sloping.

Picture of the condition of the joints before rehabilitation

**b) Action proposal:** Specific solutions were proposed for each problem (problems with joints between the sandwich panels and skylights, vents and chimneys).

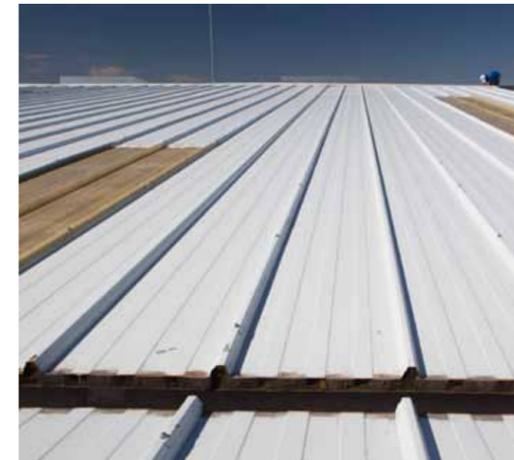
As an example of the poor quality of the previous installation, incorrect gutter placement had caused the gutters to block off water runoff, causing overflowing. This was an additional factor that eventually led to water filtering through into the industrial premises.

Picture of the gutters before rehabilitation

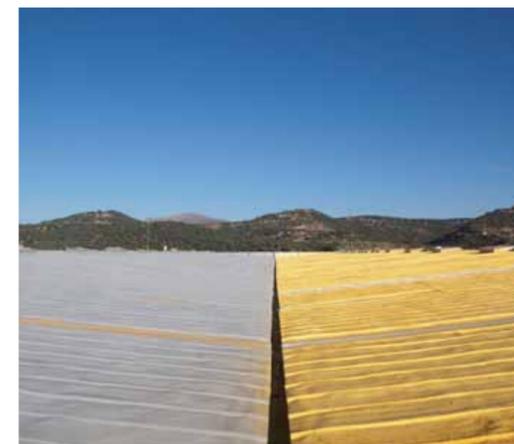
Contrast between spray foam and acrylic polymer final finish

**d) Proyección:** Finalmente se proyectó la espuma de poliuretano, y se le aplicó un acabado con una base de polímeros acrílicos para proteger el poliuretano de los efectos de la radiación solar.

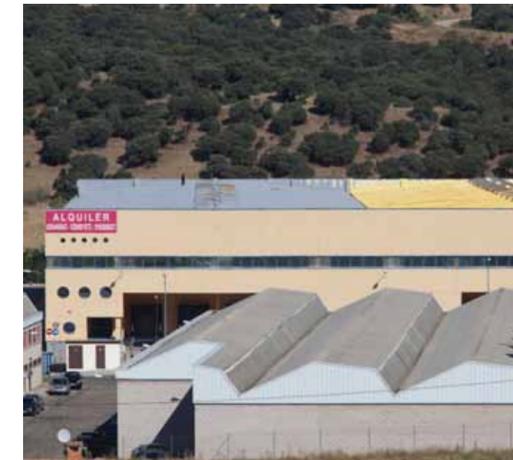
General picture of the roofing rehabilitation process

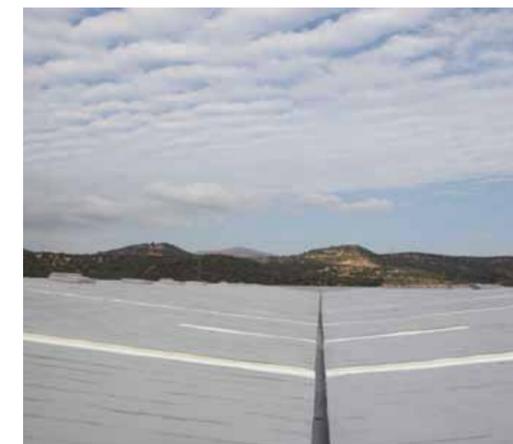
Picture of the pitched roof with final finish
